**SUPERIOR COURT OF THE DISTRICT OF COLUMBIA  
CRIMINAL DIVISION—FELONY BRANCH**

**Government’s Motion to Dismiss the Indictment**

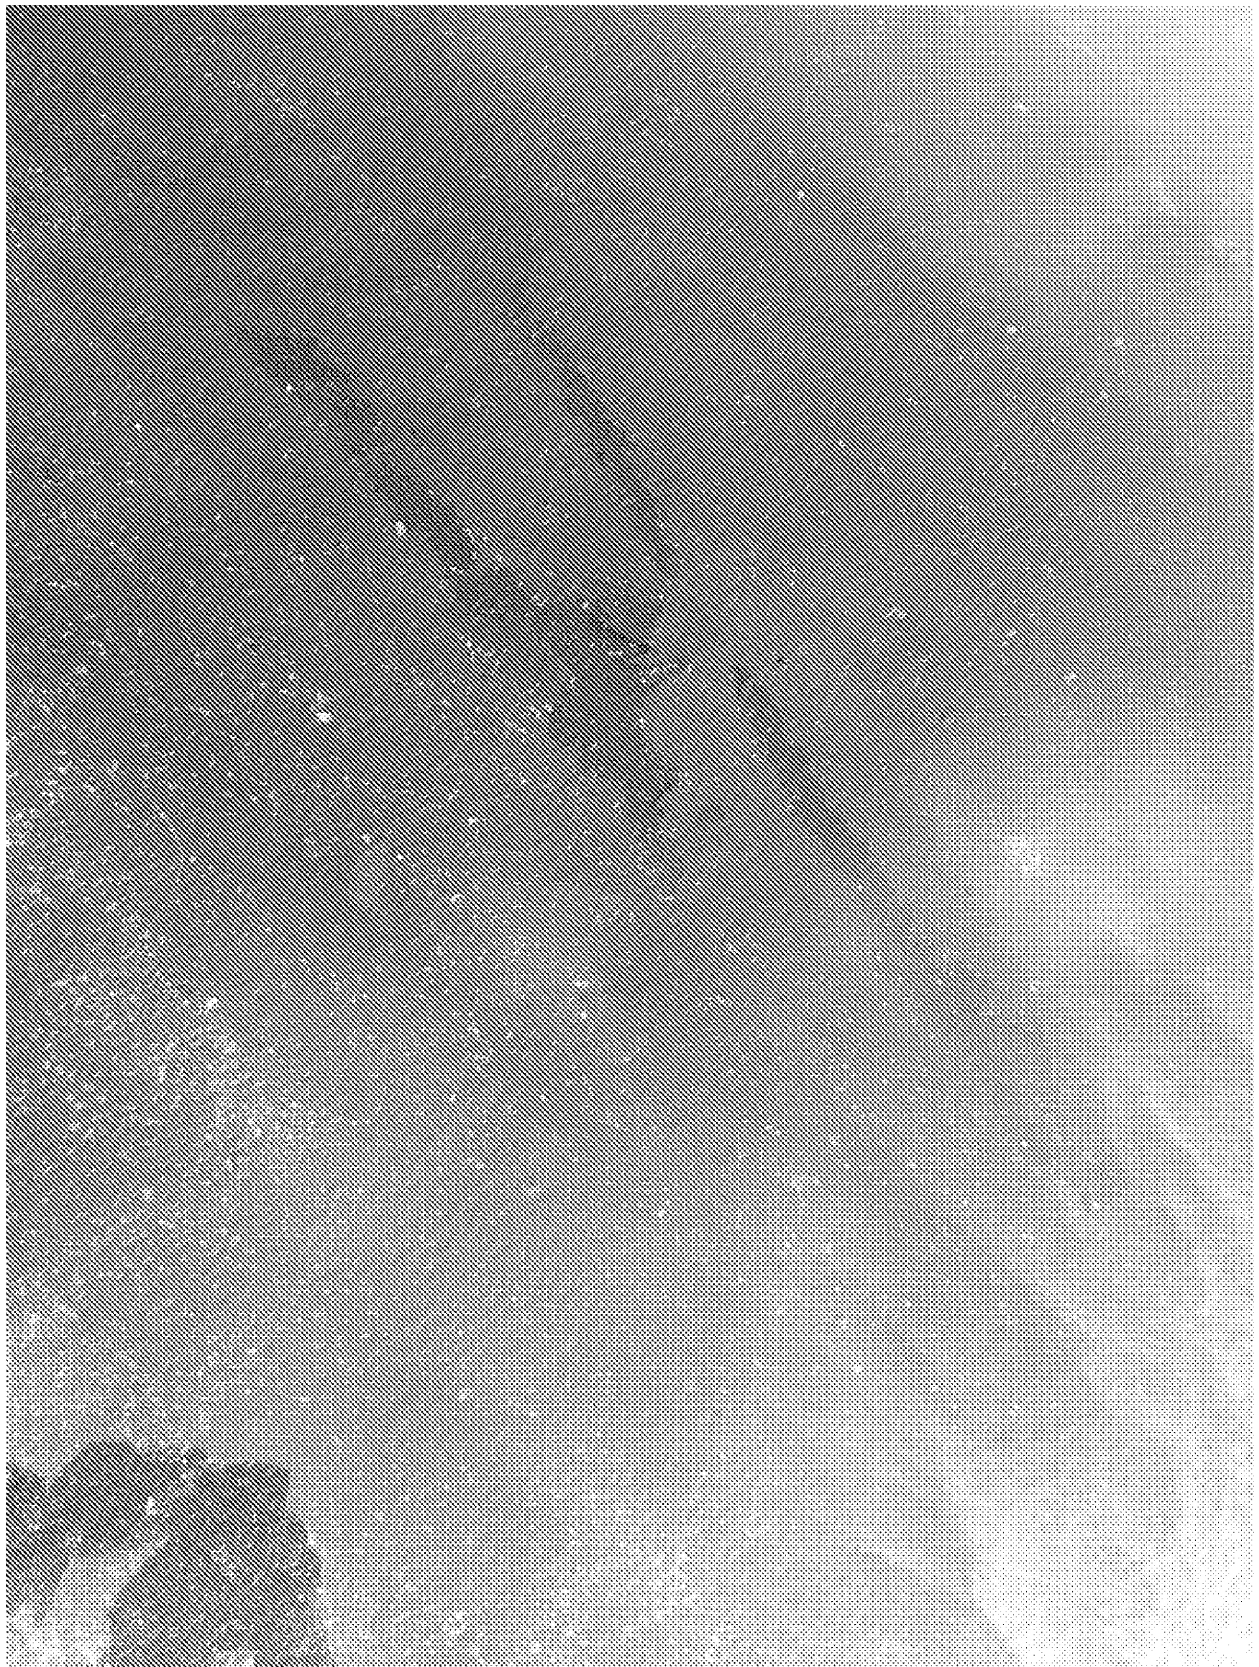
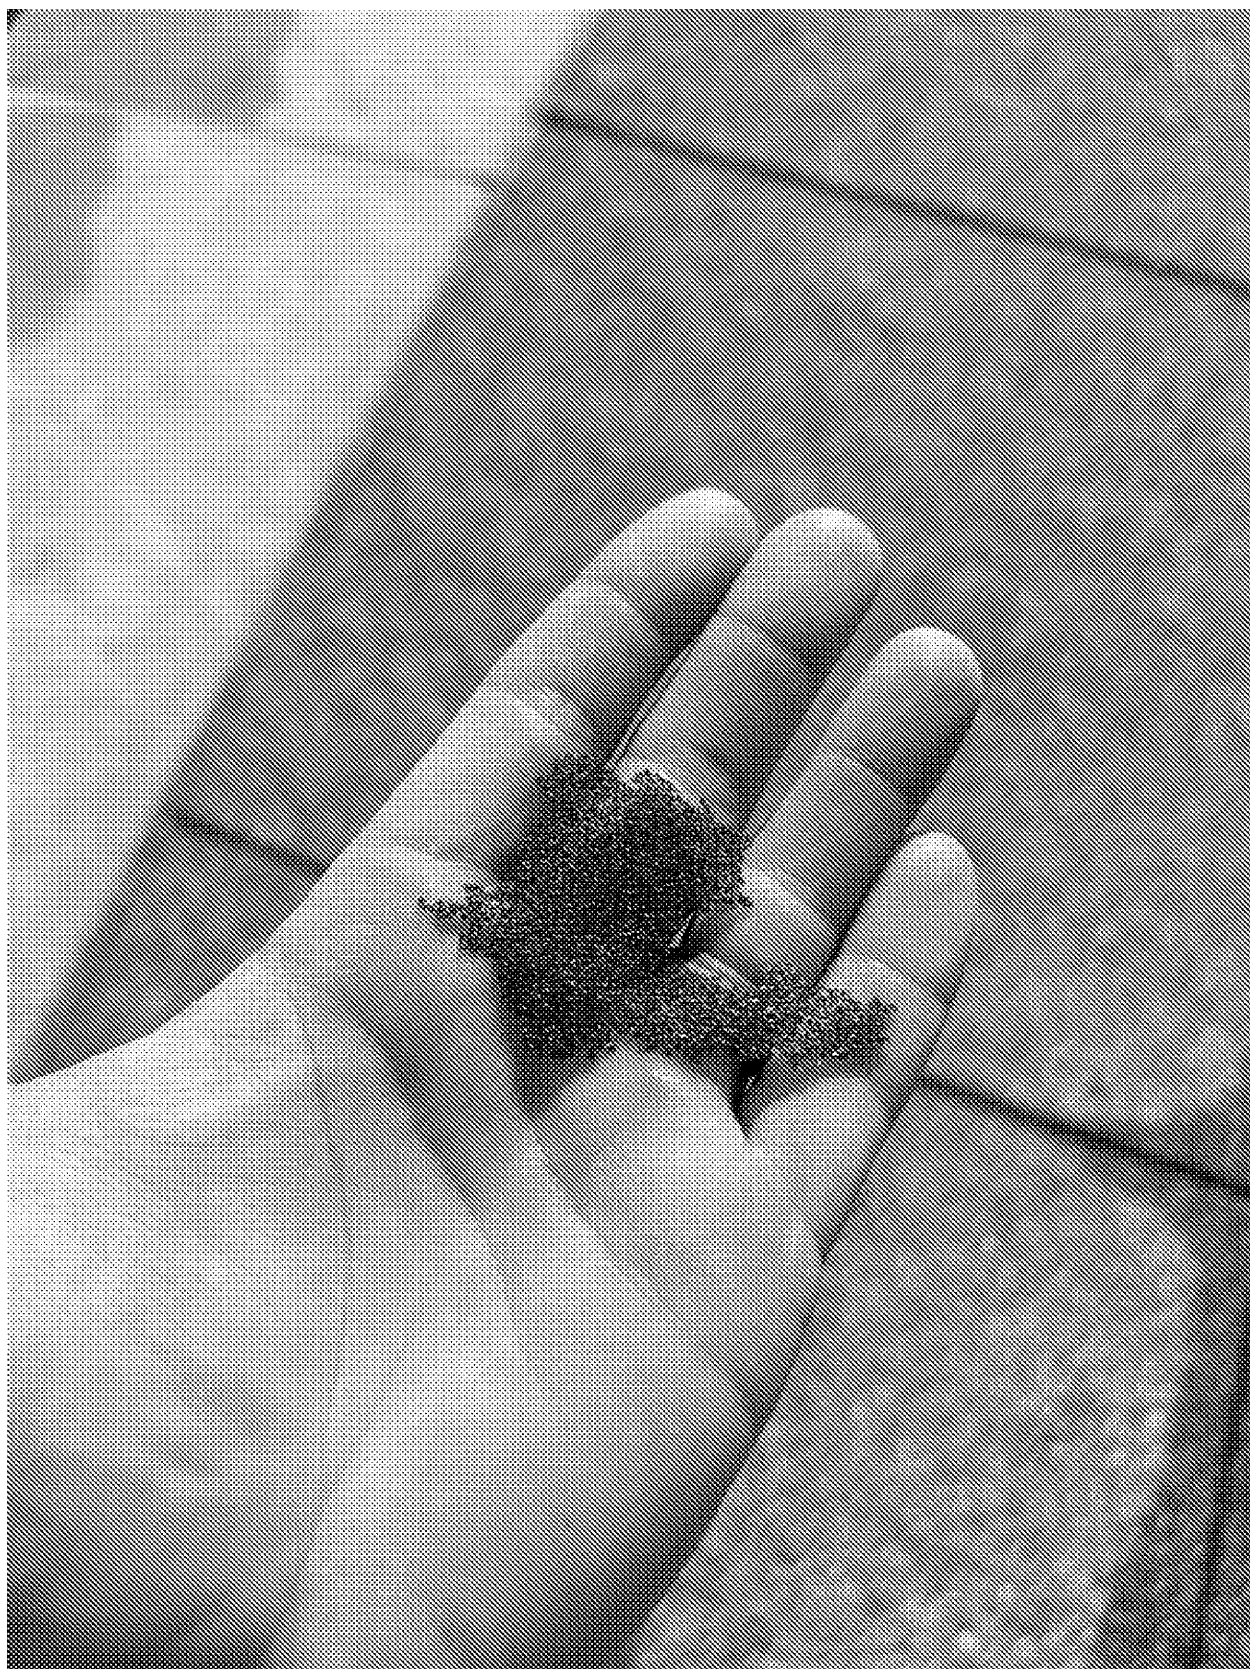
This morning, an area of the reflecting pool coating was identified to be peeling. NAMA staff was notified and I was able to inspect the area.

- Only the top layer of liner has peeled. This is very thin and will not impact the strength of the liner.
- The color underneath the peeled area is still dark, “American Flag” blue.
- The total peeled area is small, less than 1 square foot and noncontinuous.
- The contractor stated that the peeled area was “overspray” from spraying the perimeter joint with polyurea.
- I stated my concern that this “overspray” along the perimeter of the pool could lead to a 1’-2’ strip that is vulnerable to peeling. The contractor would not confirm in field if this was or wasn’t a risk.
- The polyurea liner that has peeled does not float in water, so should not be highly visible to visitors and can be vacuumed out along with sediment and algae during the normal cleaning process.
- I walked the perimeter of the pool and did not identify any additional peeling areas.

Notably, the engineer’s email recounted AIC’s explanation that peeling areas around the perimeter were “overspray” and that a one-to-two-foot strip was vulnerable to peeling. This was the area along the perimeter that the defendant is alleged to have pulled up. He also stated that the liner that has peeled does not float in the water and that peeling “will not impact the strength of the liner.” The engineer provided photographs of the peeling area:

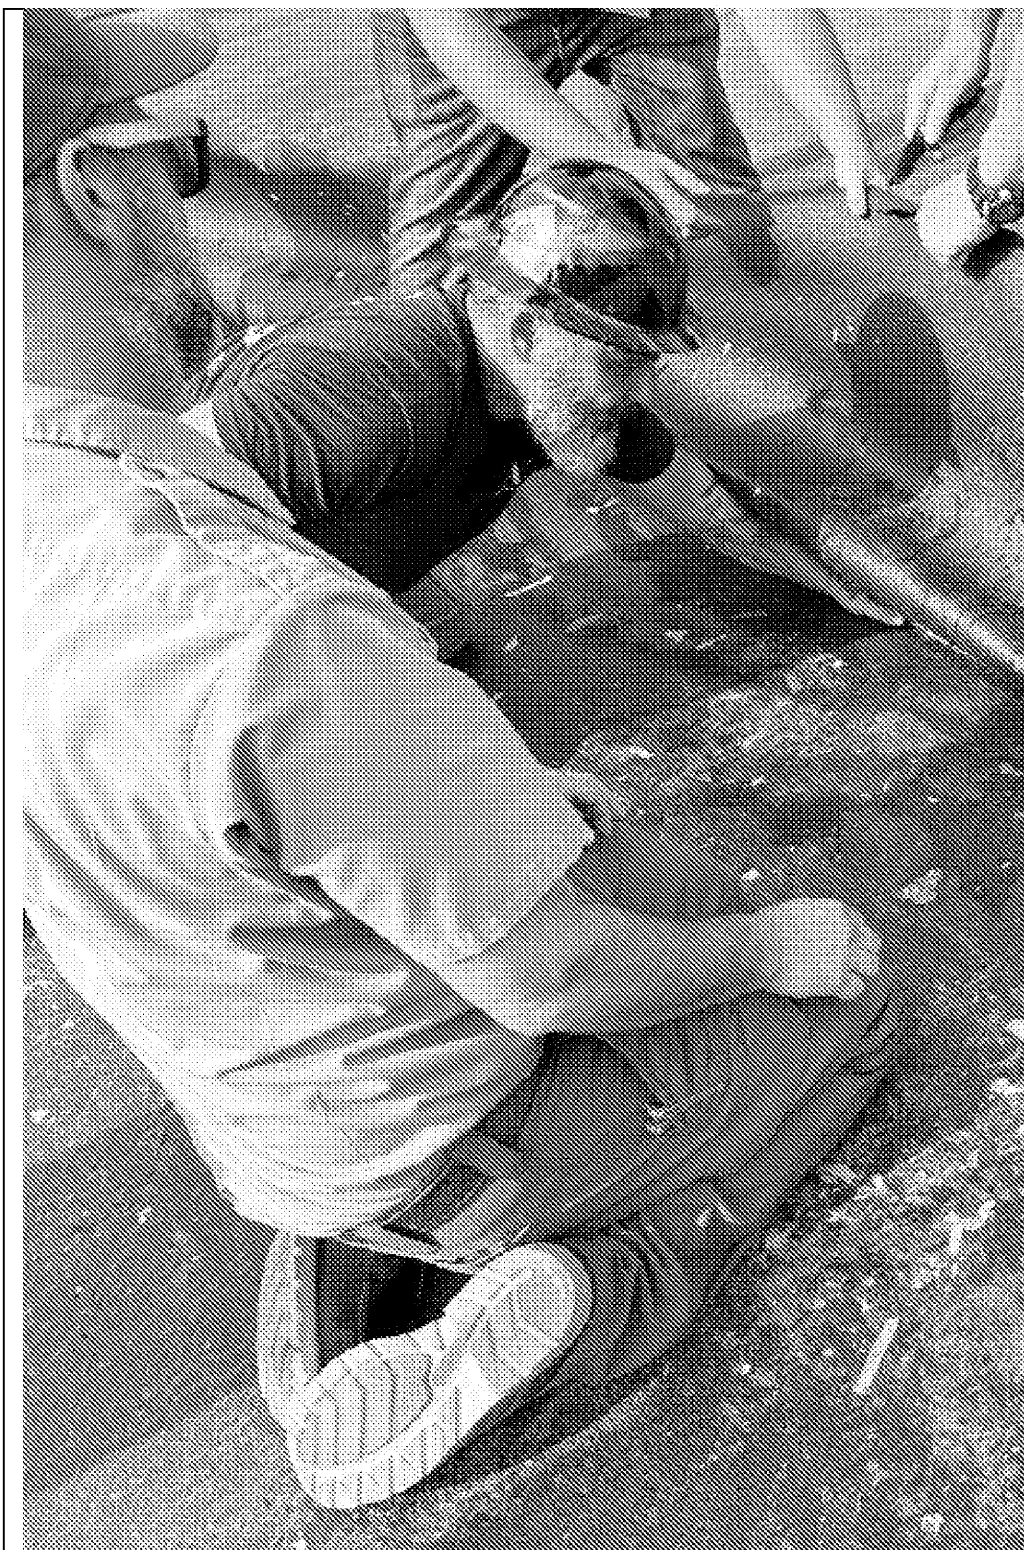
2. Each of the coating failures along the perimeter of the pool (most noteworthy in Bays 04, 06, 07 and 09) were examined in detail. Various theories were discussed as to the cause of the failures in the interface between 11-35 and Pipeliner 5000. An apparent cause of failure may be the application of too little or too much XP bonding agent.
3. At each coating failure along the perimeter, [REDACTED] of AIC proposed the following remediation: remove all existing failed material as required until firmly adhered material is encountered, power wash the exposed area to clean the substrate; grind/abrade the substrate; apply XP bonding agent; apply 11-35, apply Pipeliner 5000 for texture.
4. Many areas were observed where Pipeline 5000 was applied for texture over 11-35 and oversprayed onto existing Pipeliner 5000 and hence had not bonded. This loose material can be removed by powerwashing.

Photo #5 – Examination of delaminated coating at tranverse expansion joint between Bays 04 and 06

Although “[v]arious theories were discussed as to the cause of the failures,” overspraying and a failure of the coatings to bond predominate in the report. Three days of repairs were estimated by AIC to address the issues identified. Photographs from the report show the extent of damage to the pool caused by over spraying and delamination. Damage was noted throughout the Reflecting Pool, and not just at the perimeter.
