**SUPERIOR COURT OF THE DISTRICT OF COLUMBIA  
CRIMINAL DIVISION—FELONY BRANCH**

**Government’s Motion to Dismiss the Indictment**

### **I. The Initial Information Provided to the Government**

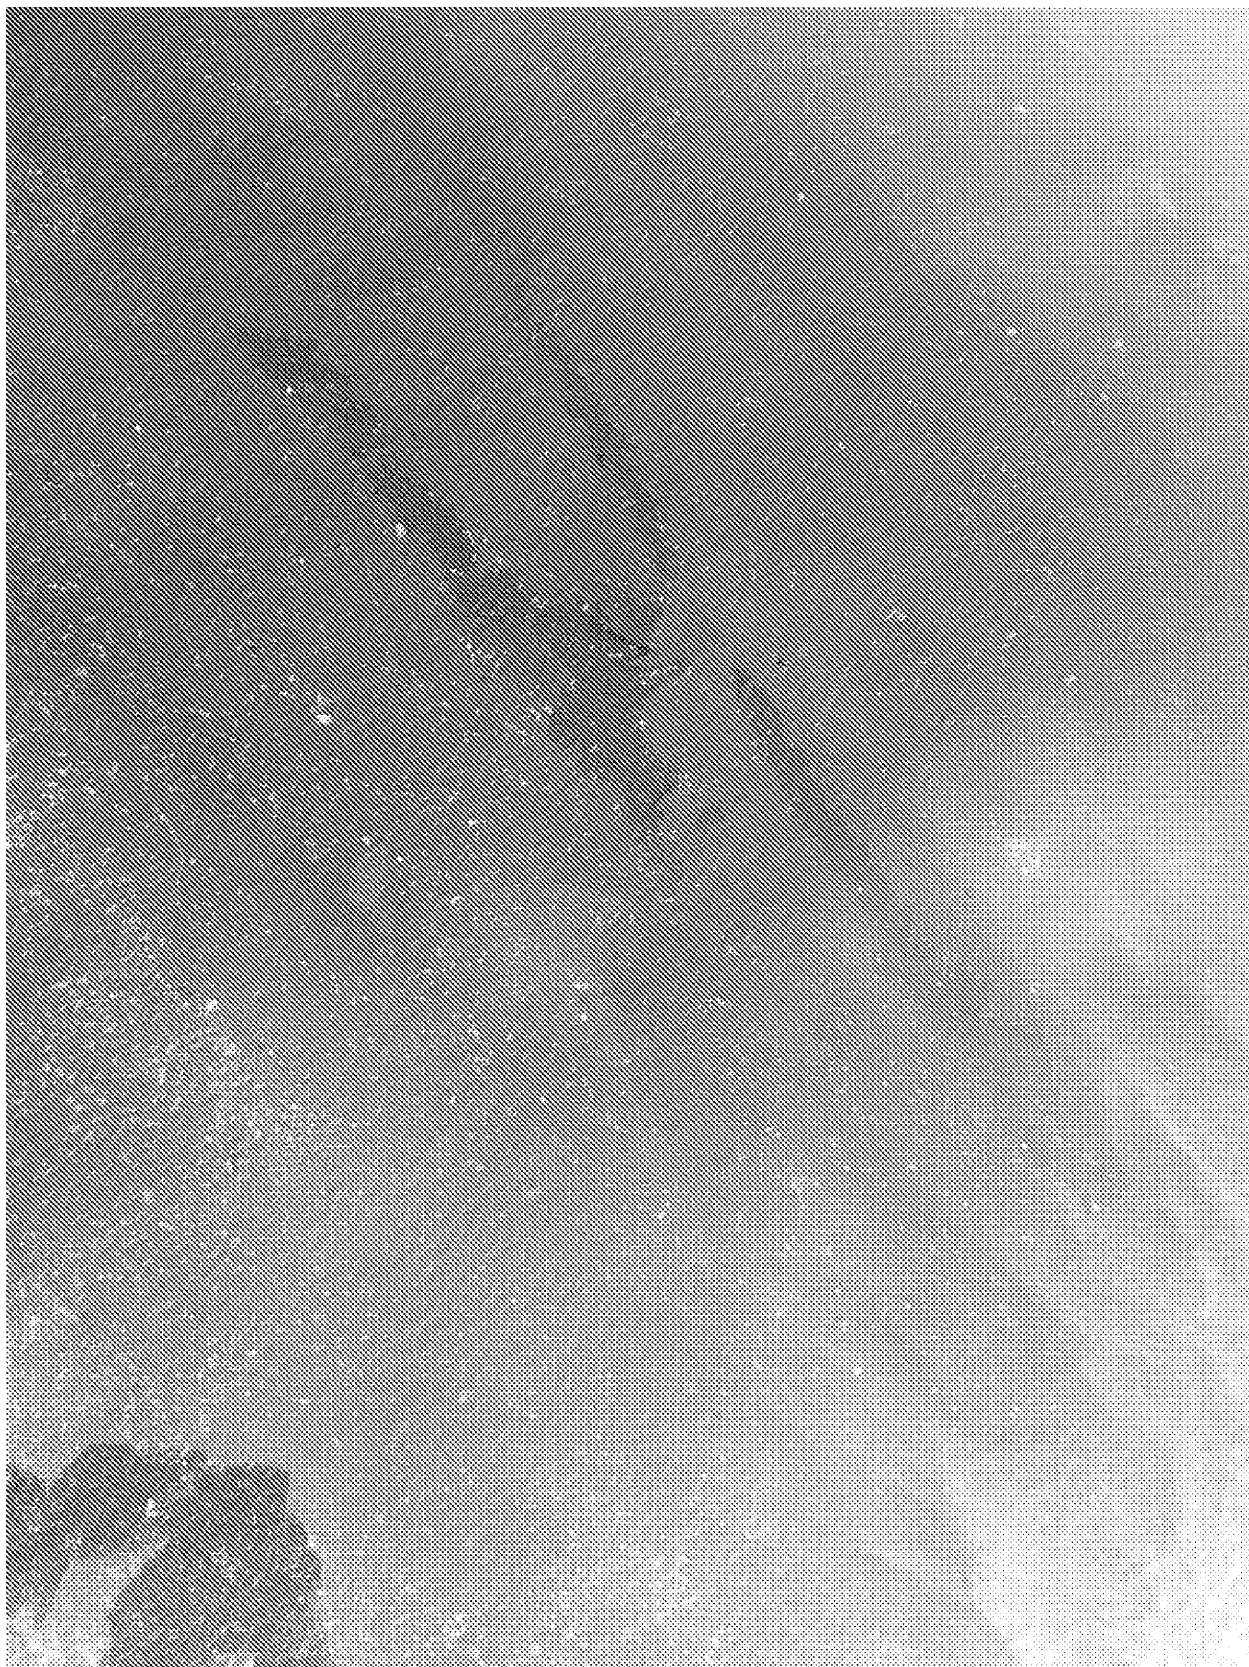
- Only the top layer of liner has peeled. This is very thin and will not impact the strength of the liner.
- The color underneath the peeled area is still dark, “American Flag” blue.
- The total peeled area is small, less than 1 square foot and noncontinuous.
- The contractor stated that the peeled area was “overspray” from spraying the perimeter joint with polyurea.
- I stated my concern that this “overspray” along the perimeter of the pool could lead to a 1’-2’ strip that is vulnerable to peeling. The contractor would not confirm in field if this was or wasn’t a risk.
- The polyurea liner that has peeled does not float in water, so should not be highly visible to visitors and can be vacuumed out along with sediment and algae during the normal cleaning process.
- I walked the perimeter of the pool and did not identify any additional peeling areas.

Notably, the engineer’s email recounted AIC’s explanation that peeling areas around the perimeter were “overspray” and that a one-to-two-foot strip was vulnerable to peeling. This was the area along the perimeter that the defendant is alleged to have pulled up. He also stated that the liner that has peeled does not float in the water and that peeling “will not impact the strength of the liner.” The engineer provided photographs of the peeling area:
